# Manhole Inspection Summary

Manhole # S37A\_\_014MH

**Inspection** ☐ Is Incomplete Rating: **5) Immediate Attention Required**

Insp Date: **9/18/08 12:13 PM**

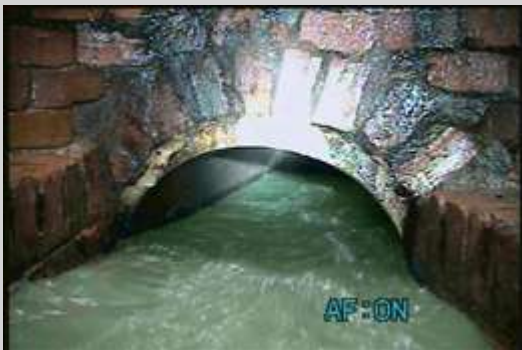
12 O'Clock Outflow

15 in. Circular Gravity Sewer  
Pipe Out @ 12 O'Clock

Invert Depth: **11.70** (ft.) Flow Characteristics: **Fast**

Infiltration: **None** Pipe Seal Cond: **Unknown**

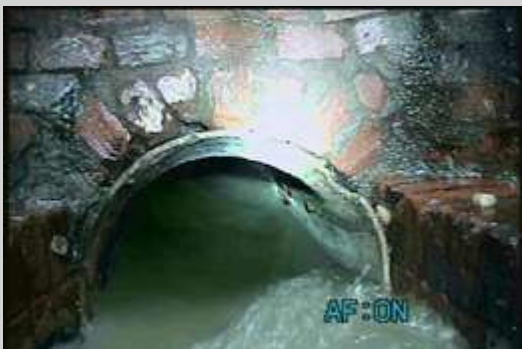
5 O'Clock Inflow

15 in. Circular Gravity Sewer  
Pipe In @ 5 O'Clock

Invert Depth: **11.60** (ft.) Flow Characteristics: **Fast**

Infiltration: **None** Pipe Seal Cond: **Unknown**

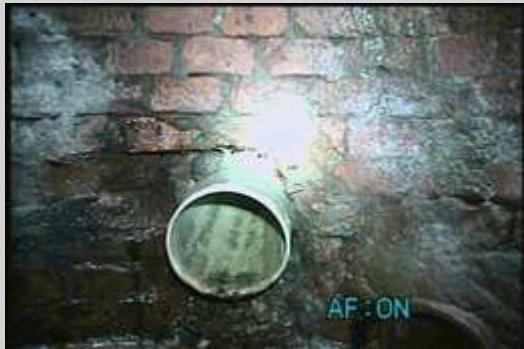
7 O'Clock Inflow

6 in. Circular Gravity Sewer

Pipe In @ 7 O'Clock

Pipe Material: **PVC** ☐ Pipe Lined

Infiltration: **None**
